Manhole Inspection Summary

Manhole # S21G__032MH

Insp Date: **8/27/07 7:36 AM**

Location Address: **32 MOUNT ST**

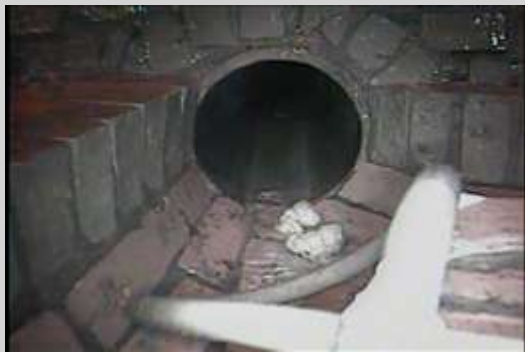
12 O'Clock Outflow

Pipe Height: **8.4** (in.) Rod and Bar (Angled)
Pipe Material: **Clay** ☐ Pipe Lined
Invert Depth: **10.28** (ft.) Flow Characteristics: **Slow**
Deposits: ☒ None ☐ Mud ☐ Sludge ☐ Debris ☐ Grease
Silt Depth: (in.) Deposits Extent:
Infiltration: **None** Pipe Seal Cond: **Sound**

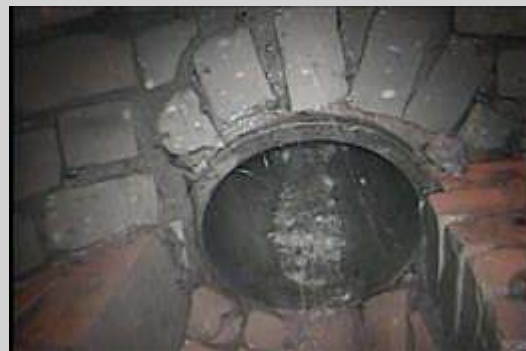
Drop In @ 3 O'Clock

Drop: **Outside** Rod and Bar
Angled: **Yes** Reading: **8.94** (ft.)
Inv Depth: **9.94** (ft.)
Drop Condition: **Open**

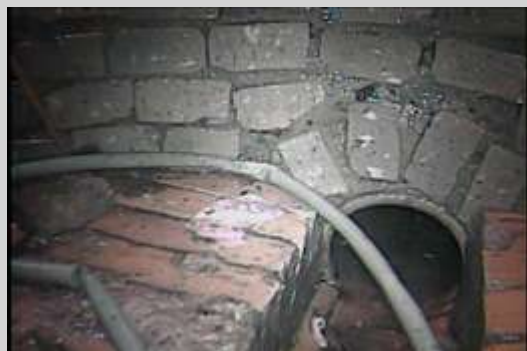
8 O'Clock Inflow

Pipe Height: **6** (in.) Rod and Bar (Angled)

Infiltration: **None**
